Permit Number 20874(01)
Galveston Consolidated Drainage Dist.
September 2, 2004
Page 1 of 14

**COWARD CREEK BANK REPAIR
EXISTING CONDITIONS PLAN VIEW**

**GALVESTON COUNTY CONSOLIDATED DRAINAGE DISTRICT
UNAUTHORIZED FILL IN COWARDS CREEK,
BETWEEN GREENBRIAR DRIVE AND AN EXISTING OIL SEPERATOR,
GALVESTON COUNTY, TEXAS**

MITIGATION AND MONITORING PLAN

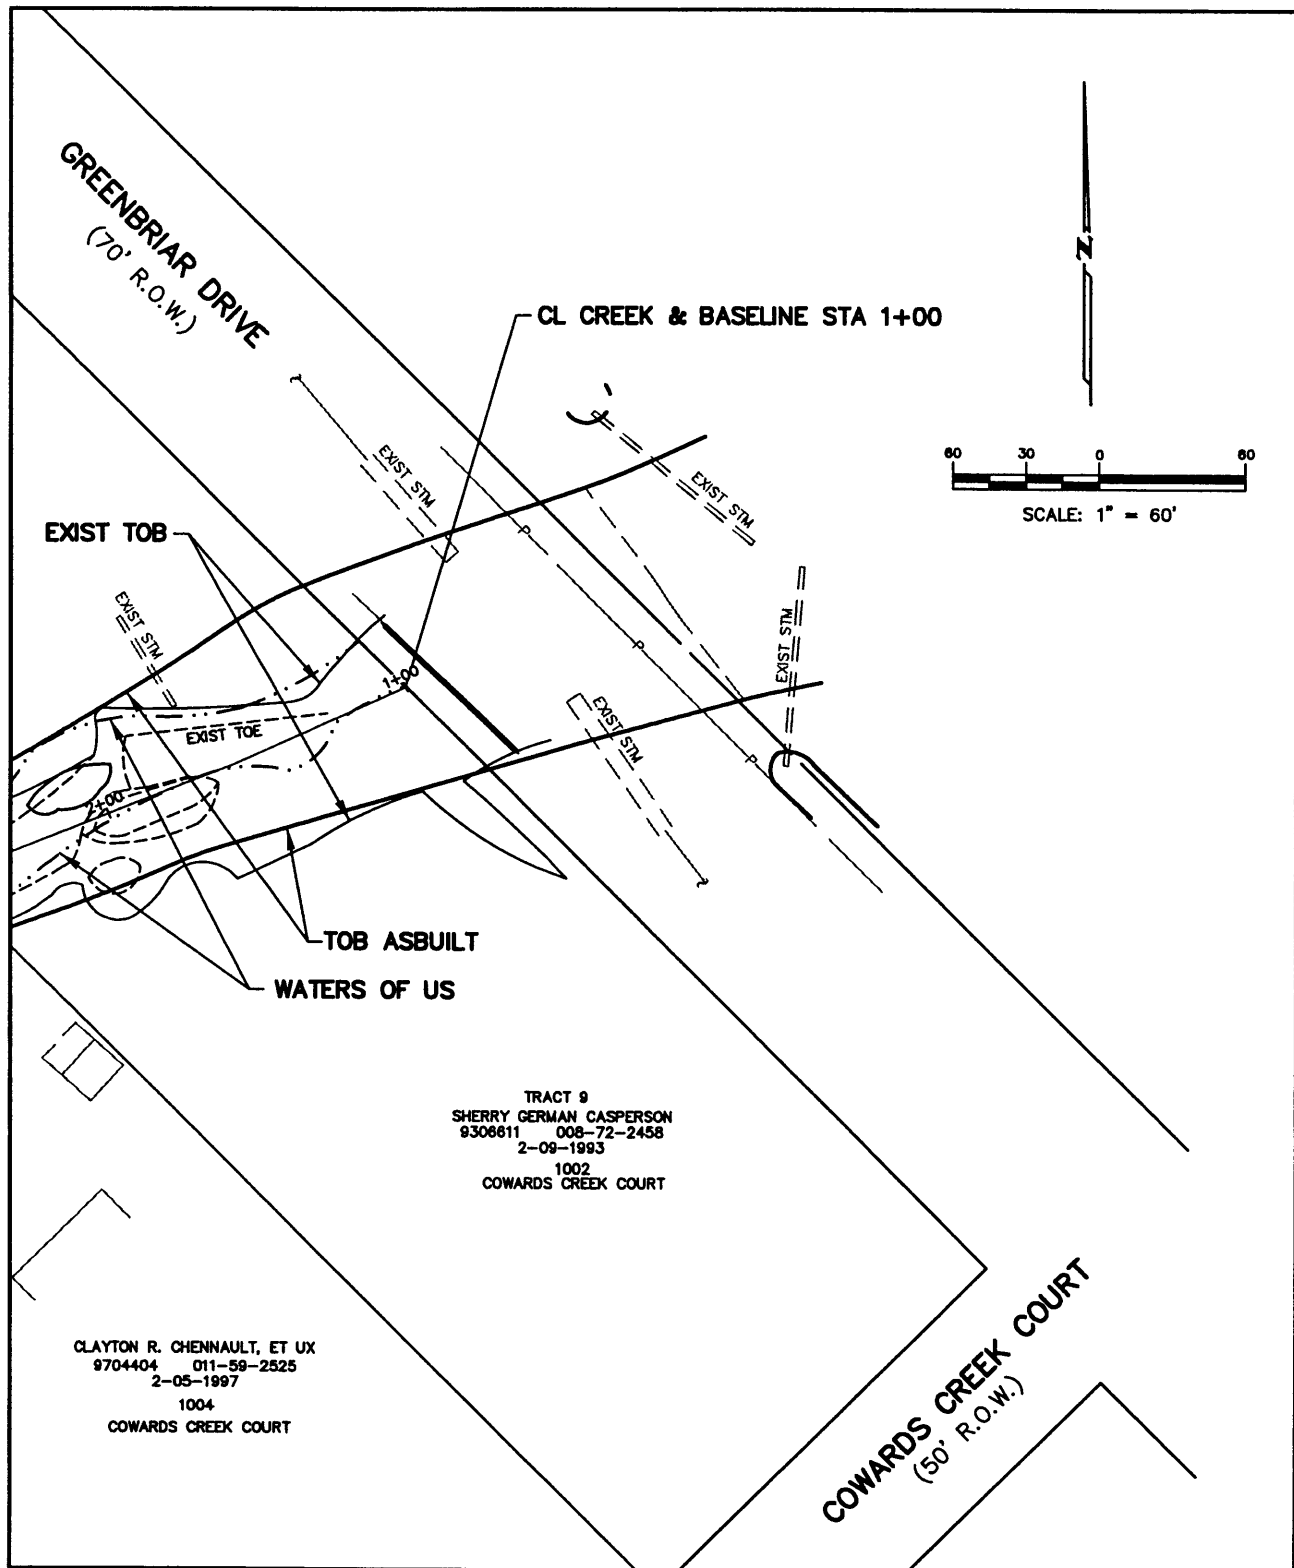
FIGURE 2

**COWARD CREEK BANK REPAIR
EXISTING CONDITIONS PLAN VIEW**

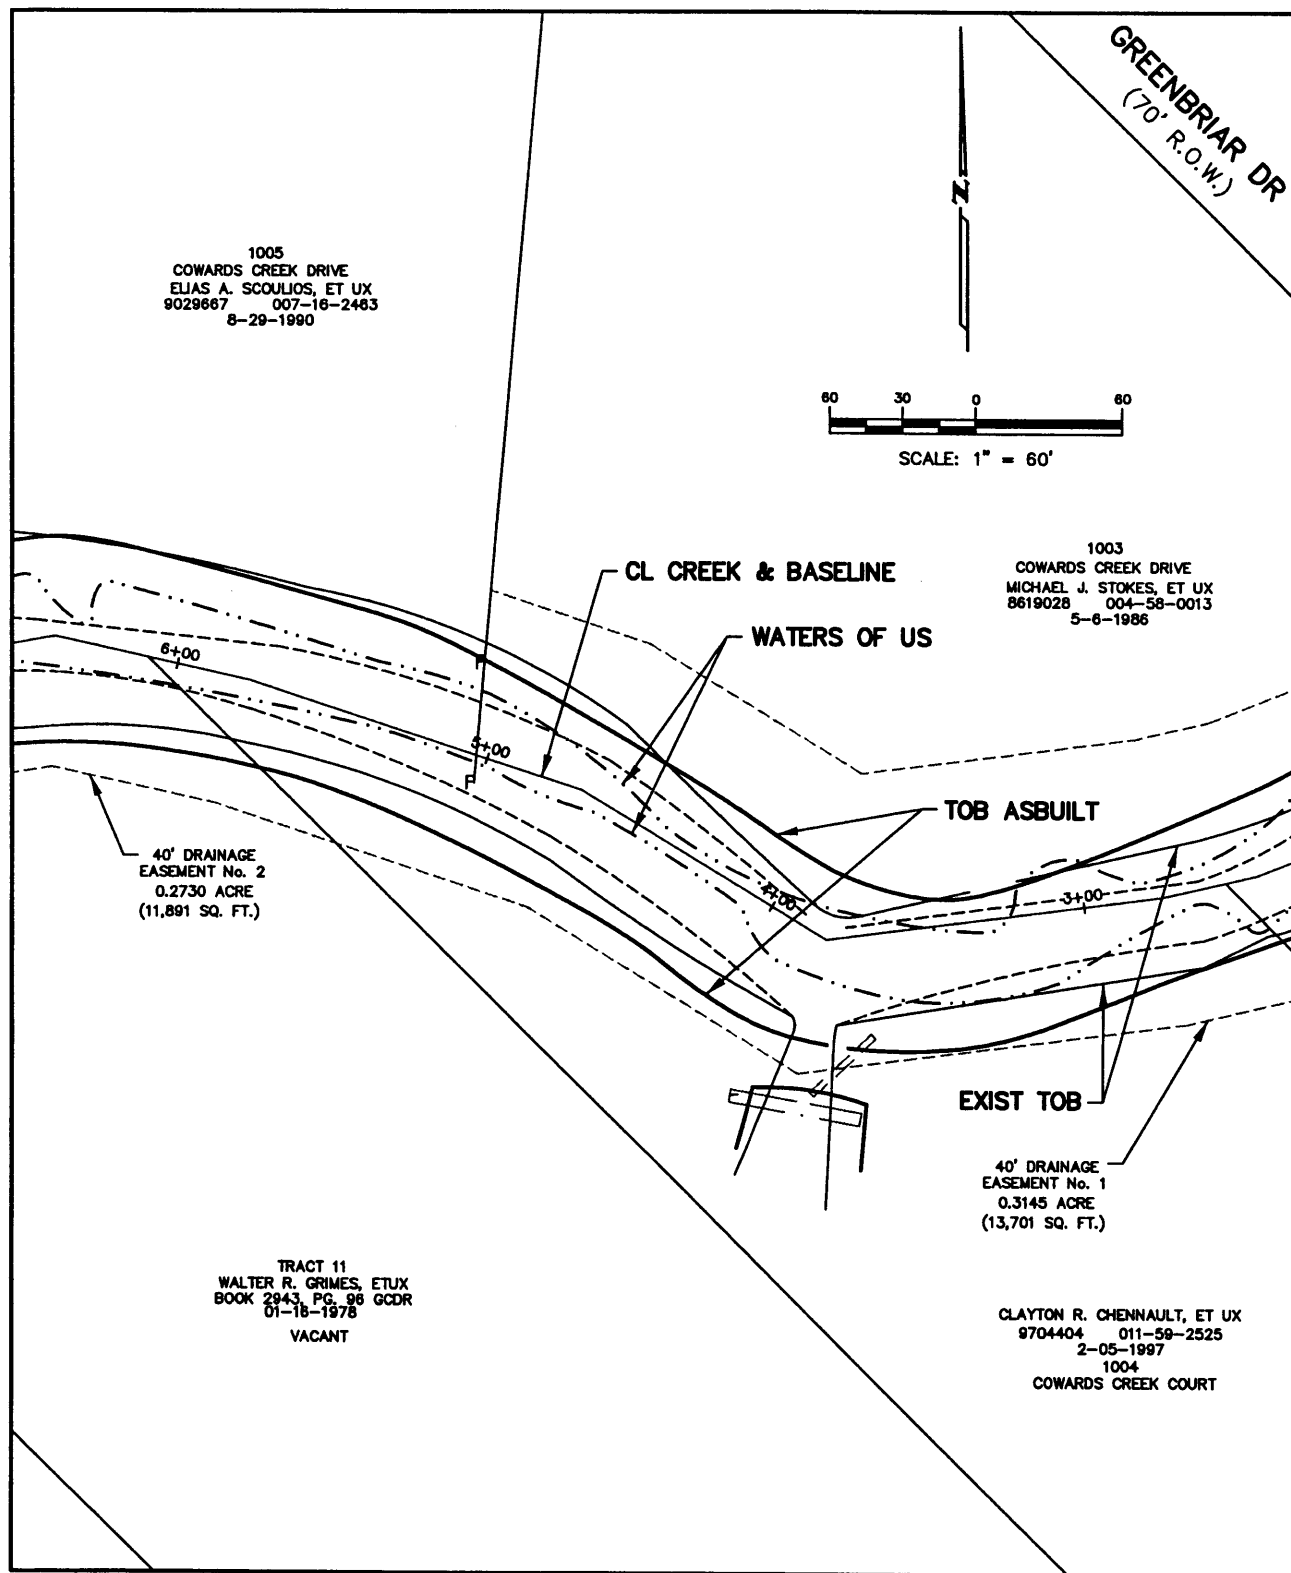
FIGURE 2

**COWARD CREEK BANK REPAIR
EXISTING CONDITIONS PLAN VIEW**

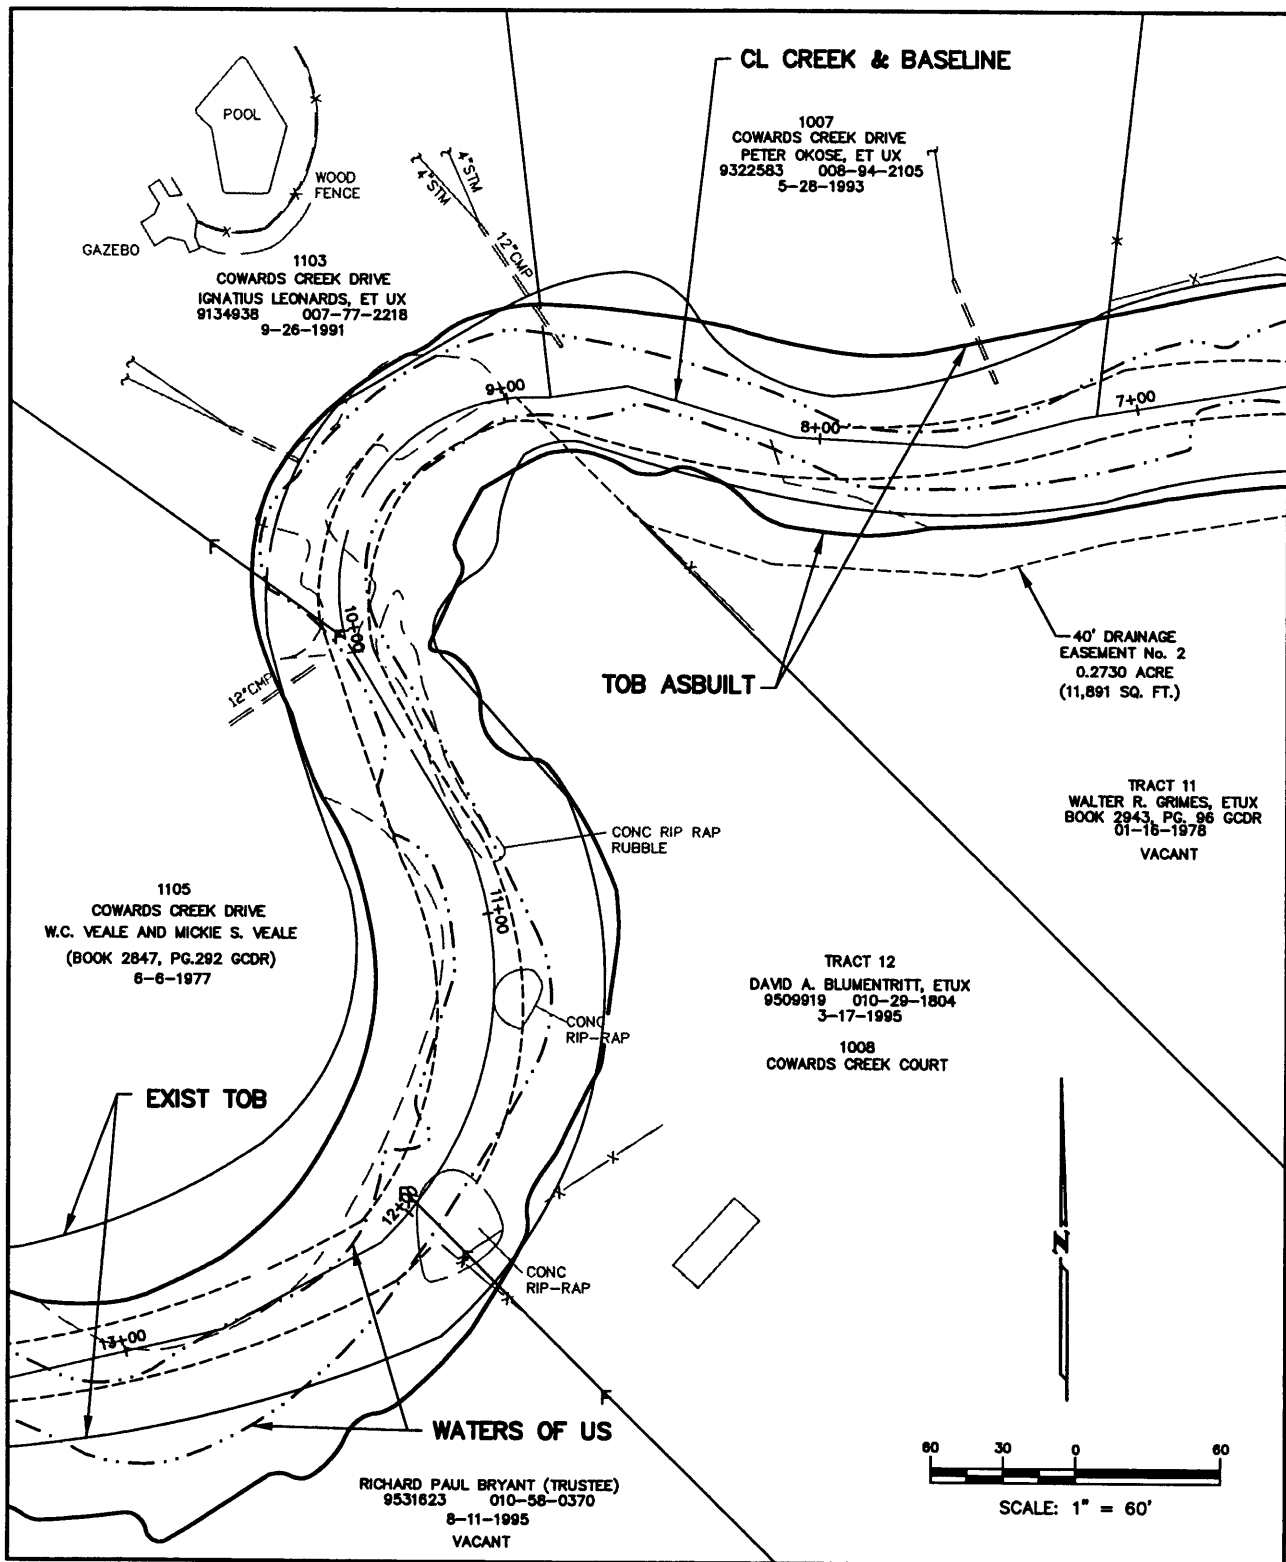
FIGURE 2

**COWARD CREEK BANK REPAIR
EXISTING CONDITIONS PLAN VIEW**

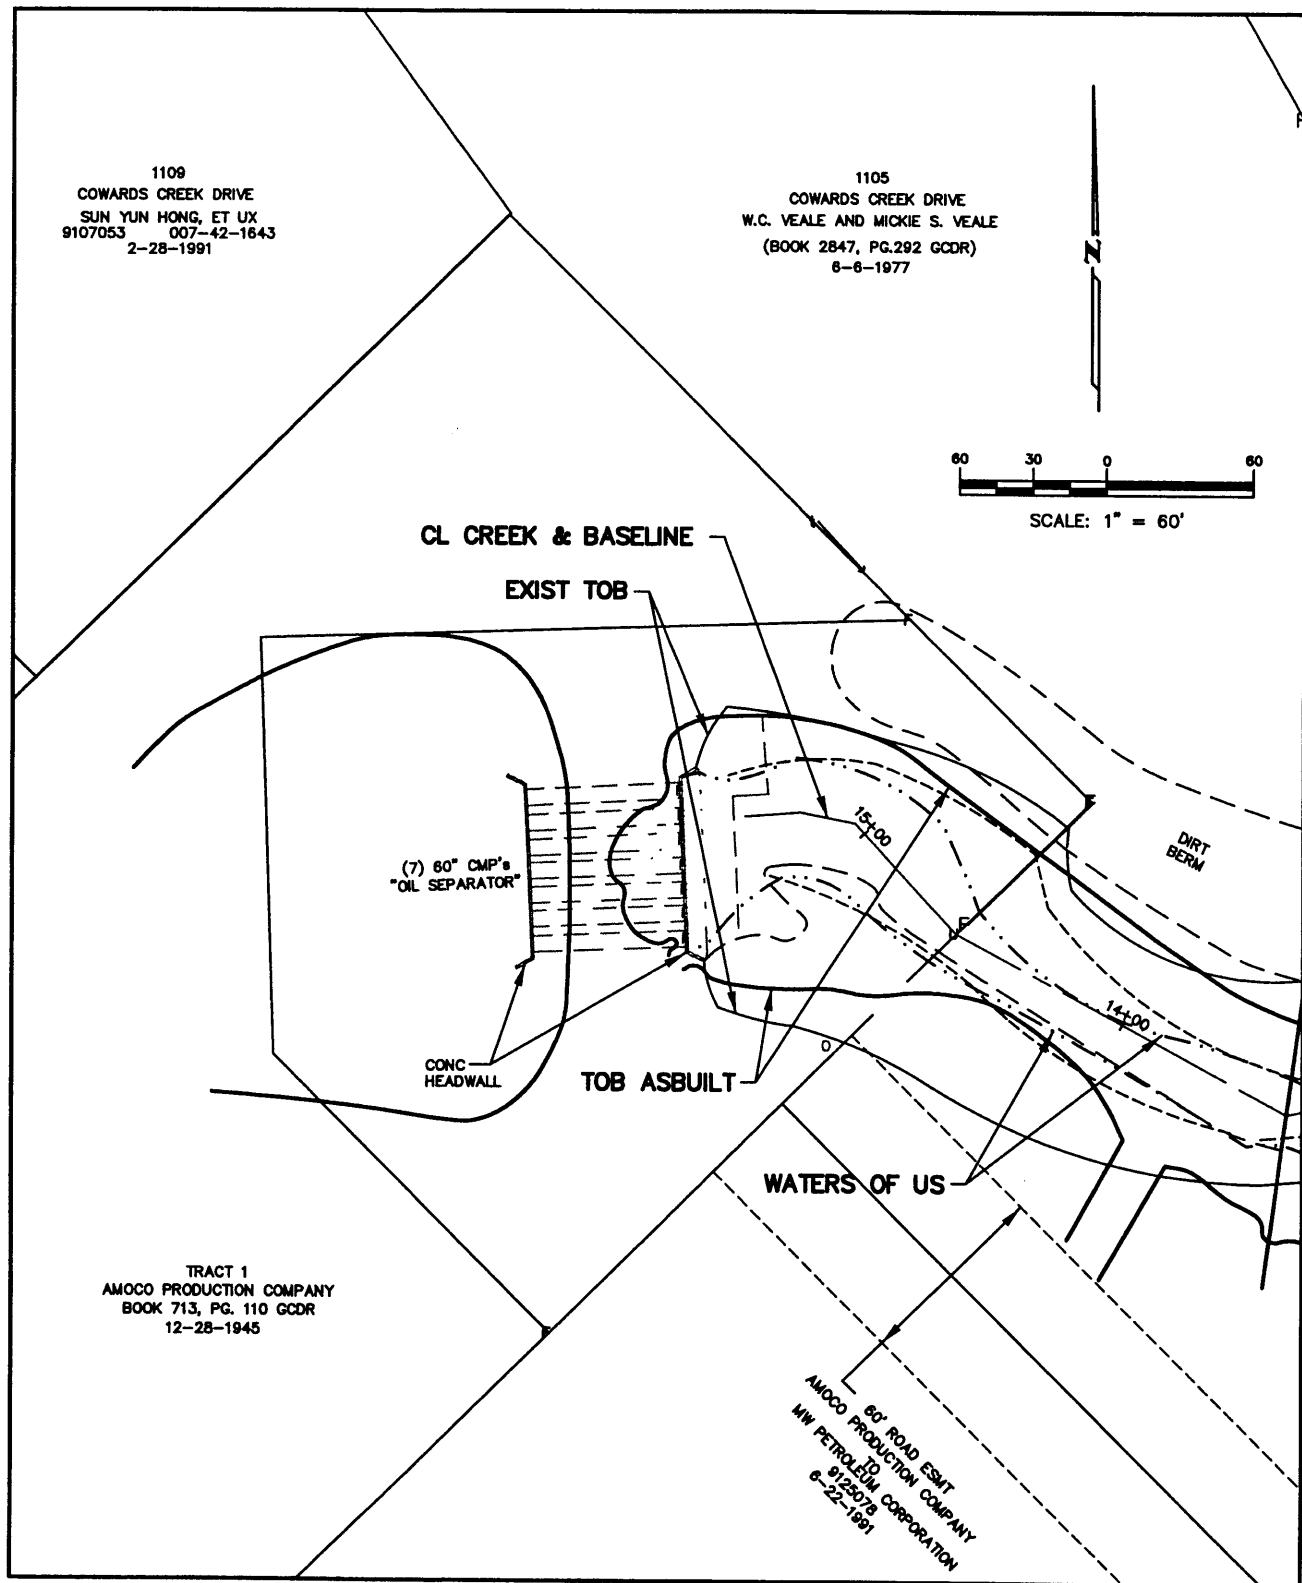
FIGURE 2

**COWARD CREEK BANK REPAIR
EXISTING CONDITIONS PLAN VIEW**

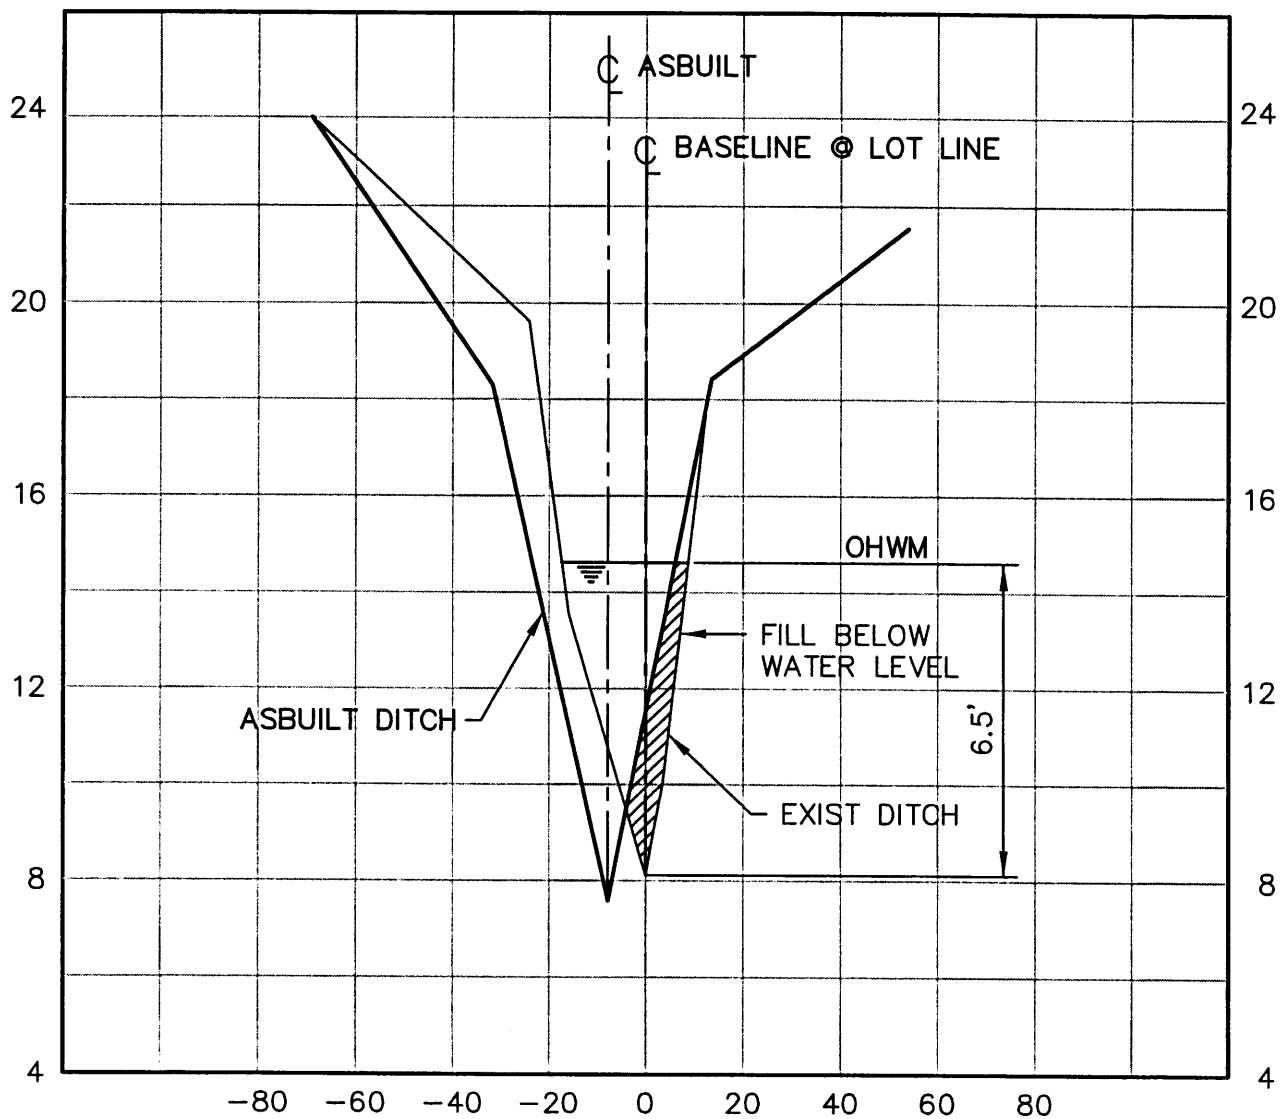
FIGURE 3

STA 3+00

COWARD CREEK BANK REPAIR
EXISTING CONDITIONS
CROSS-SECTION VIEW
GALVESTON COUNTY CONSOLIDATED
DRAINAGE DISTRICT

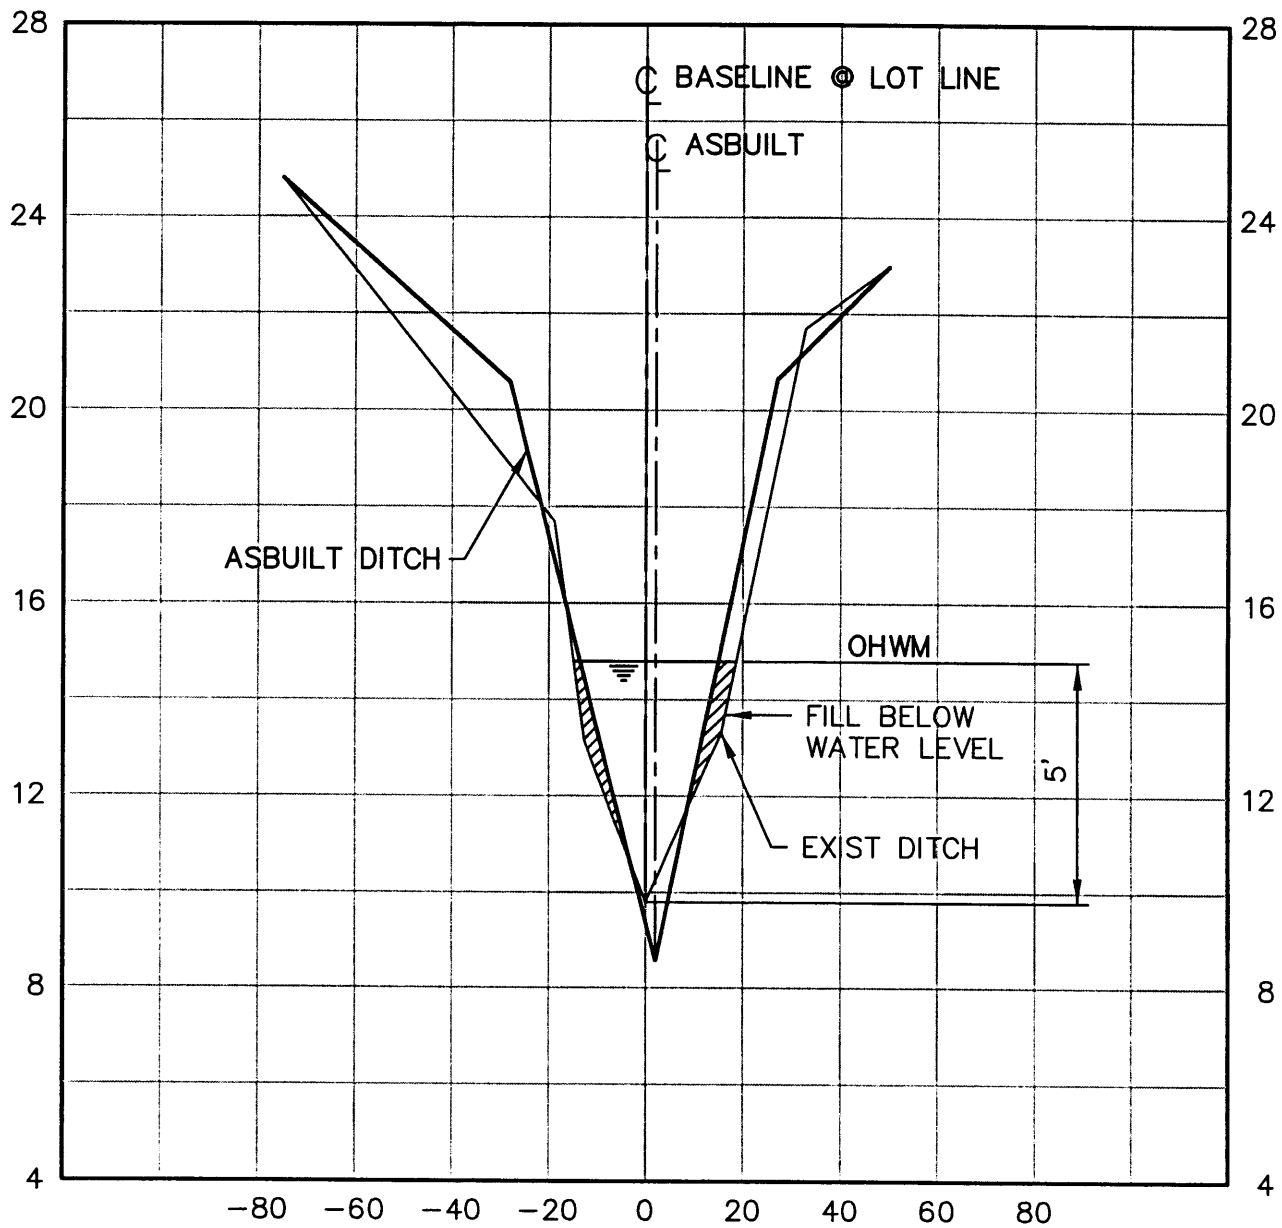
FIGURE 3

STA 5+00

COWARD CREEK BANK REPAIR
EXISTING CONDITIONS
CROSS-SECTION VIEW
GALVESTON COUNTY CONSOLIDATED
DRAINAGE DISTRICT

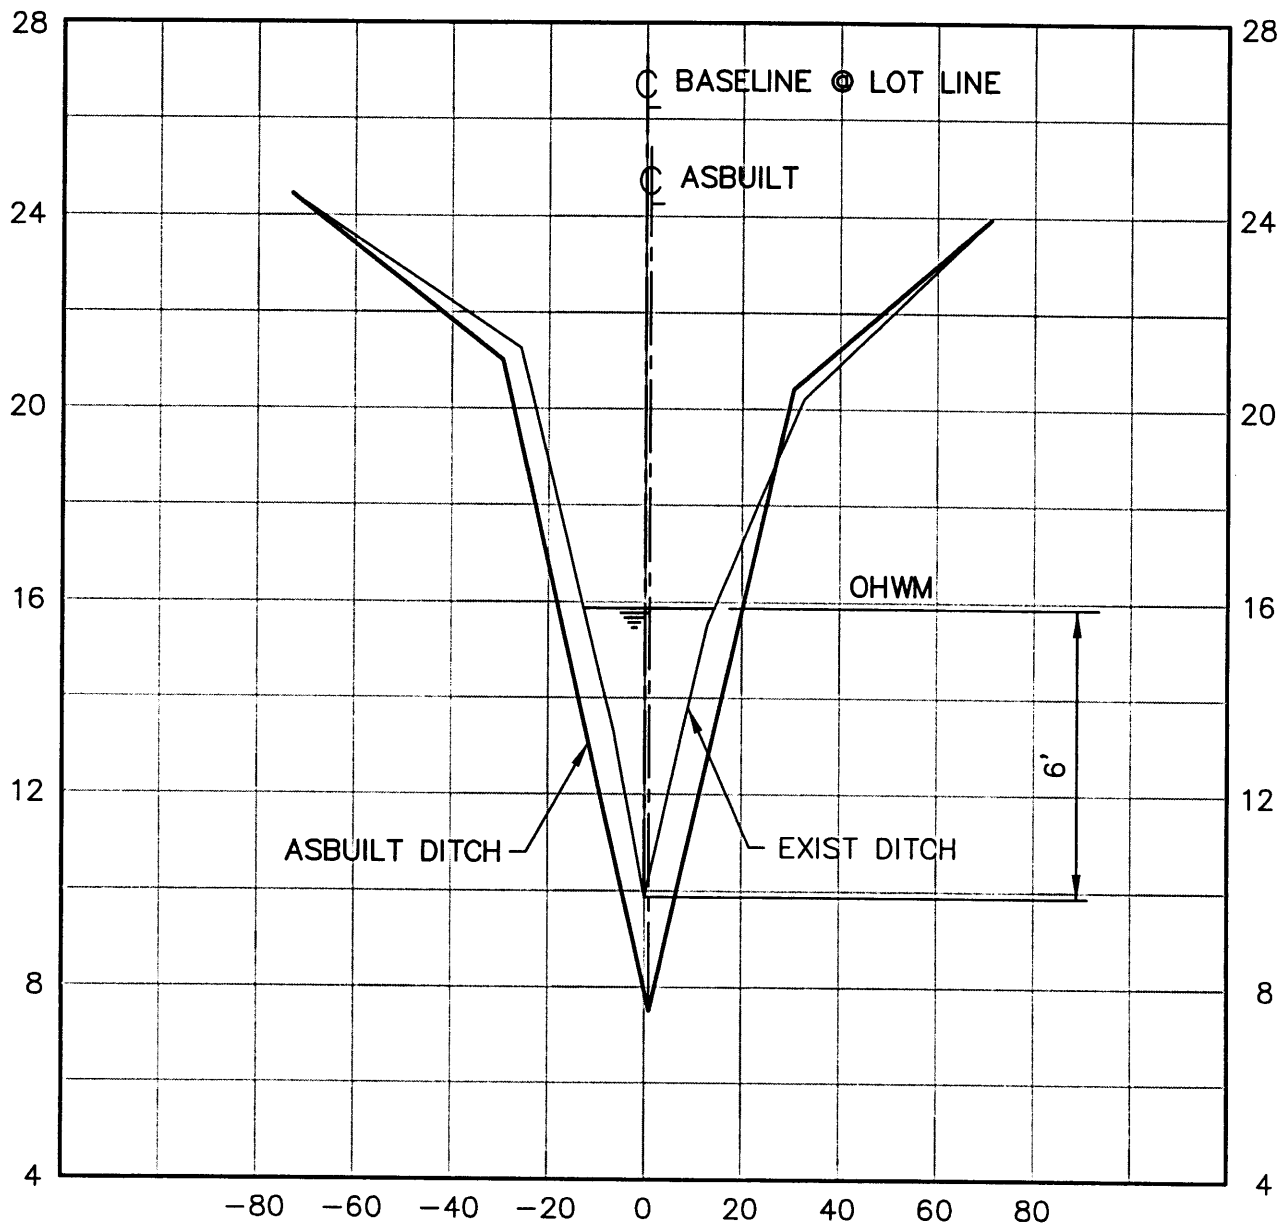
FIGURE 3

STA 7+00

COWARD CREEK BANK REPAIR
EXISTING CONDITIONS
CROSS-SECTION VIEW
GALVESTON COUNTY CONSOLIDATED
DRAINAGE DISTRICT

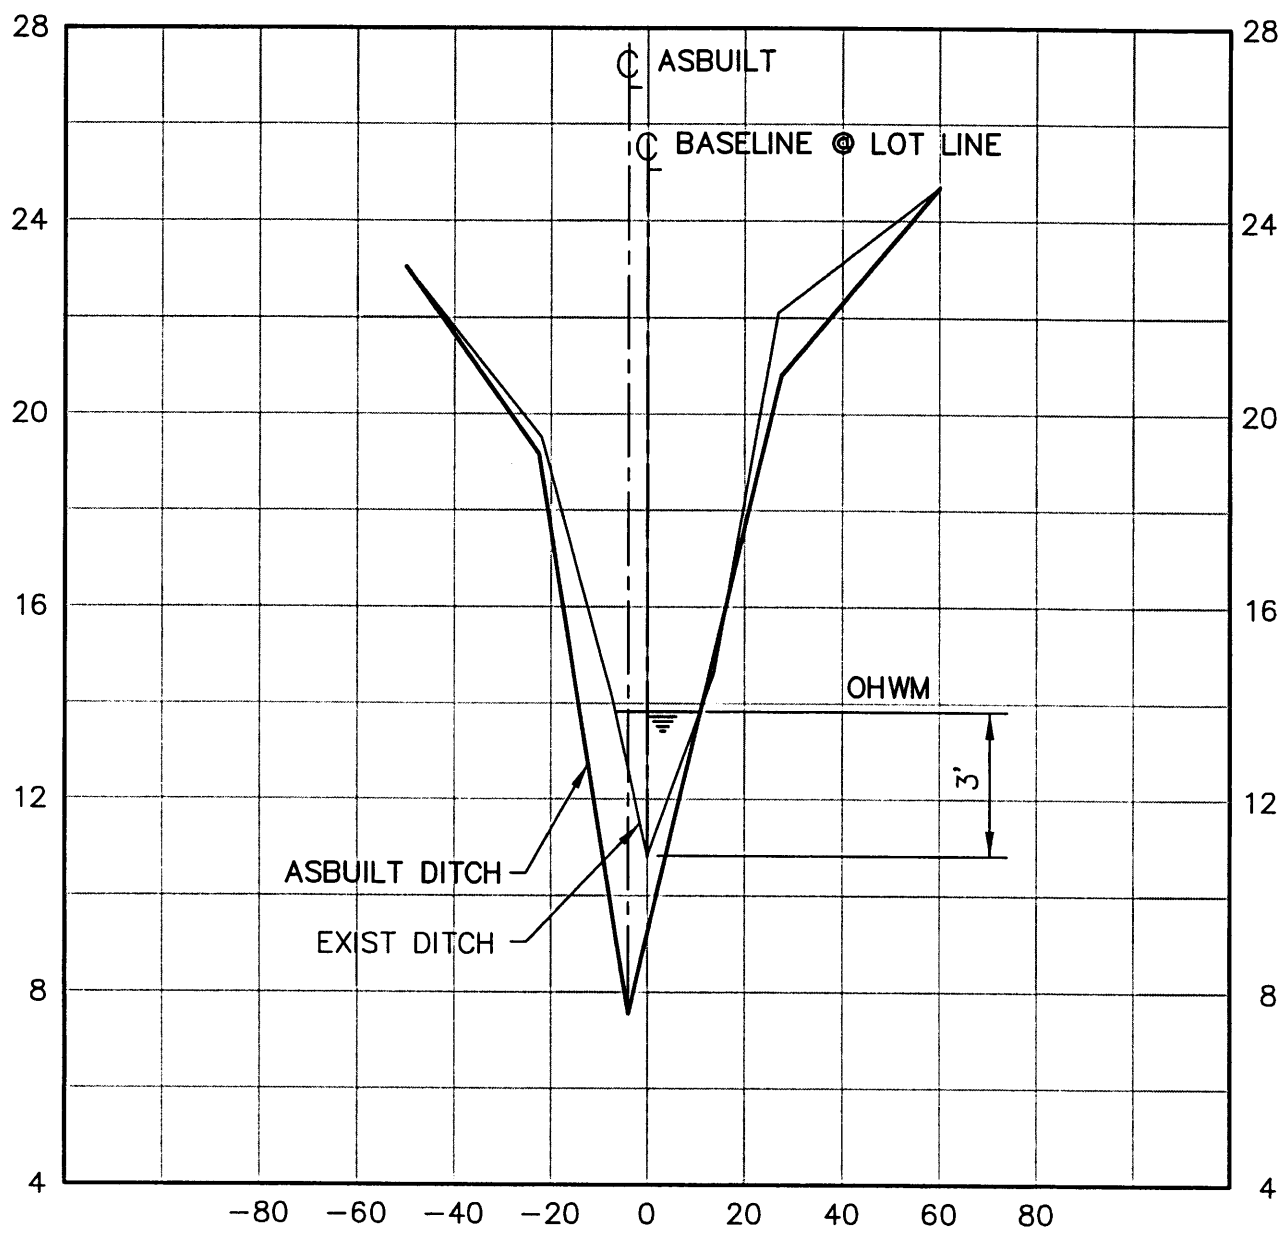
STA 9+00

COWARD CREEK BANK REPAIR
EXISTING CONDITIONS
CROSS-SECTION VIEW
GALVESTON COUNTY CONSOLIDATED
DRAINAGE DISTRICT

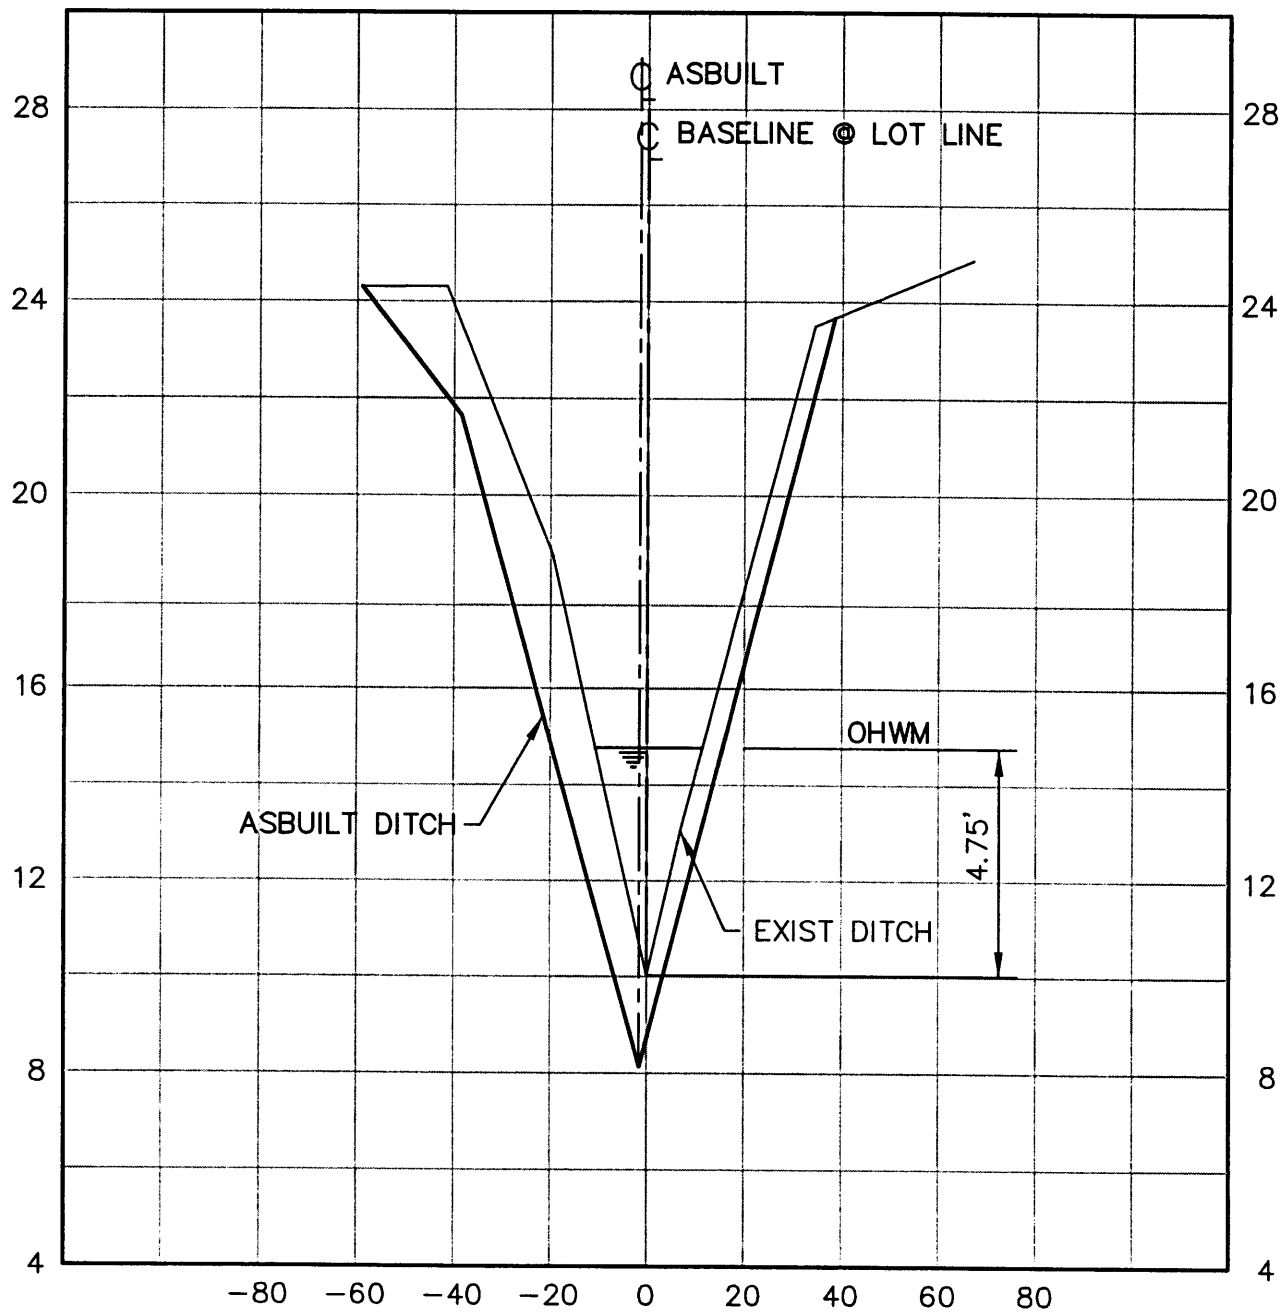
FIGURE 3

STA 11+00

COWARD CREEK BANK REPAIR
EXISTING CONDITIONS
CROSS-SECTION VIEW
GALVESTON COUNTY CONSOLIDATED
DRAINAGE DISTRICT

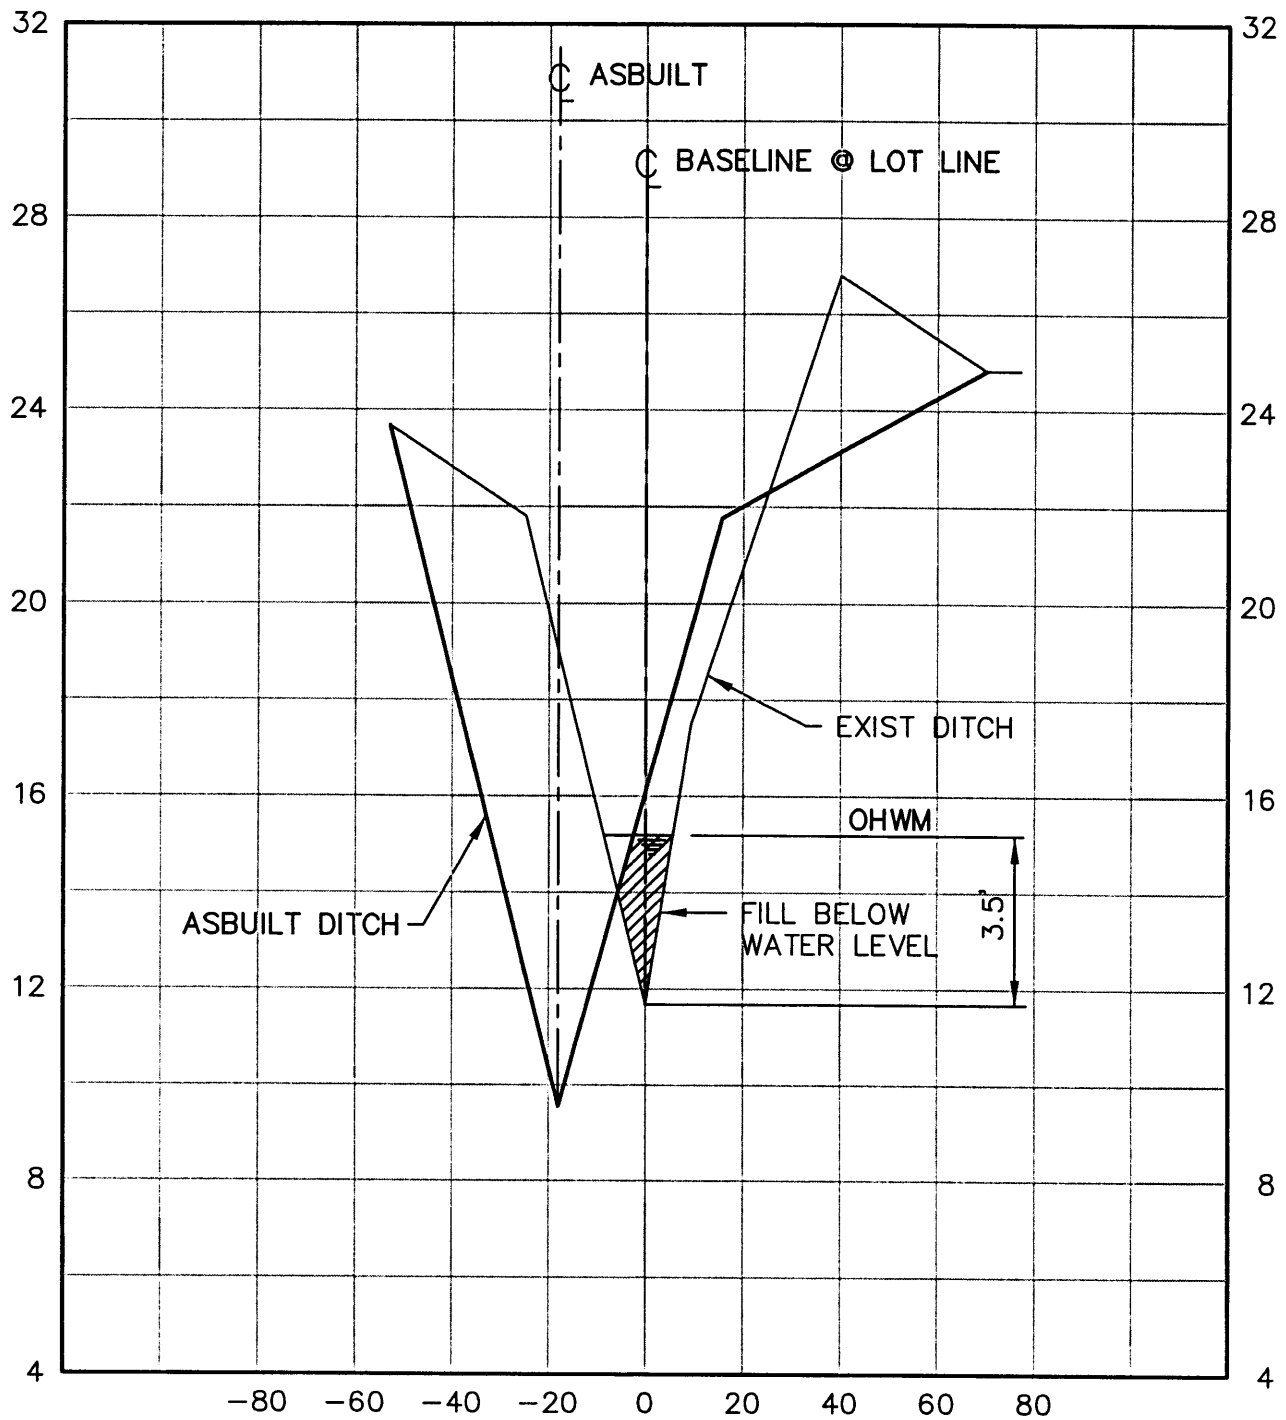
FIGURE 3

STA 13+00

COWARD CREEK BANK REPAIR
EXISTING CONDITIONS
CROSS-SECTION VIEW
GALVESTON COUNTY CONSOLIDATED
DRAINAGE DISTRICT

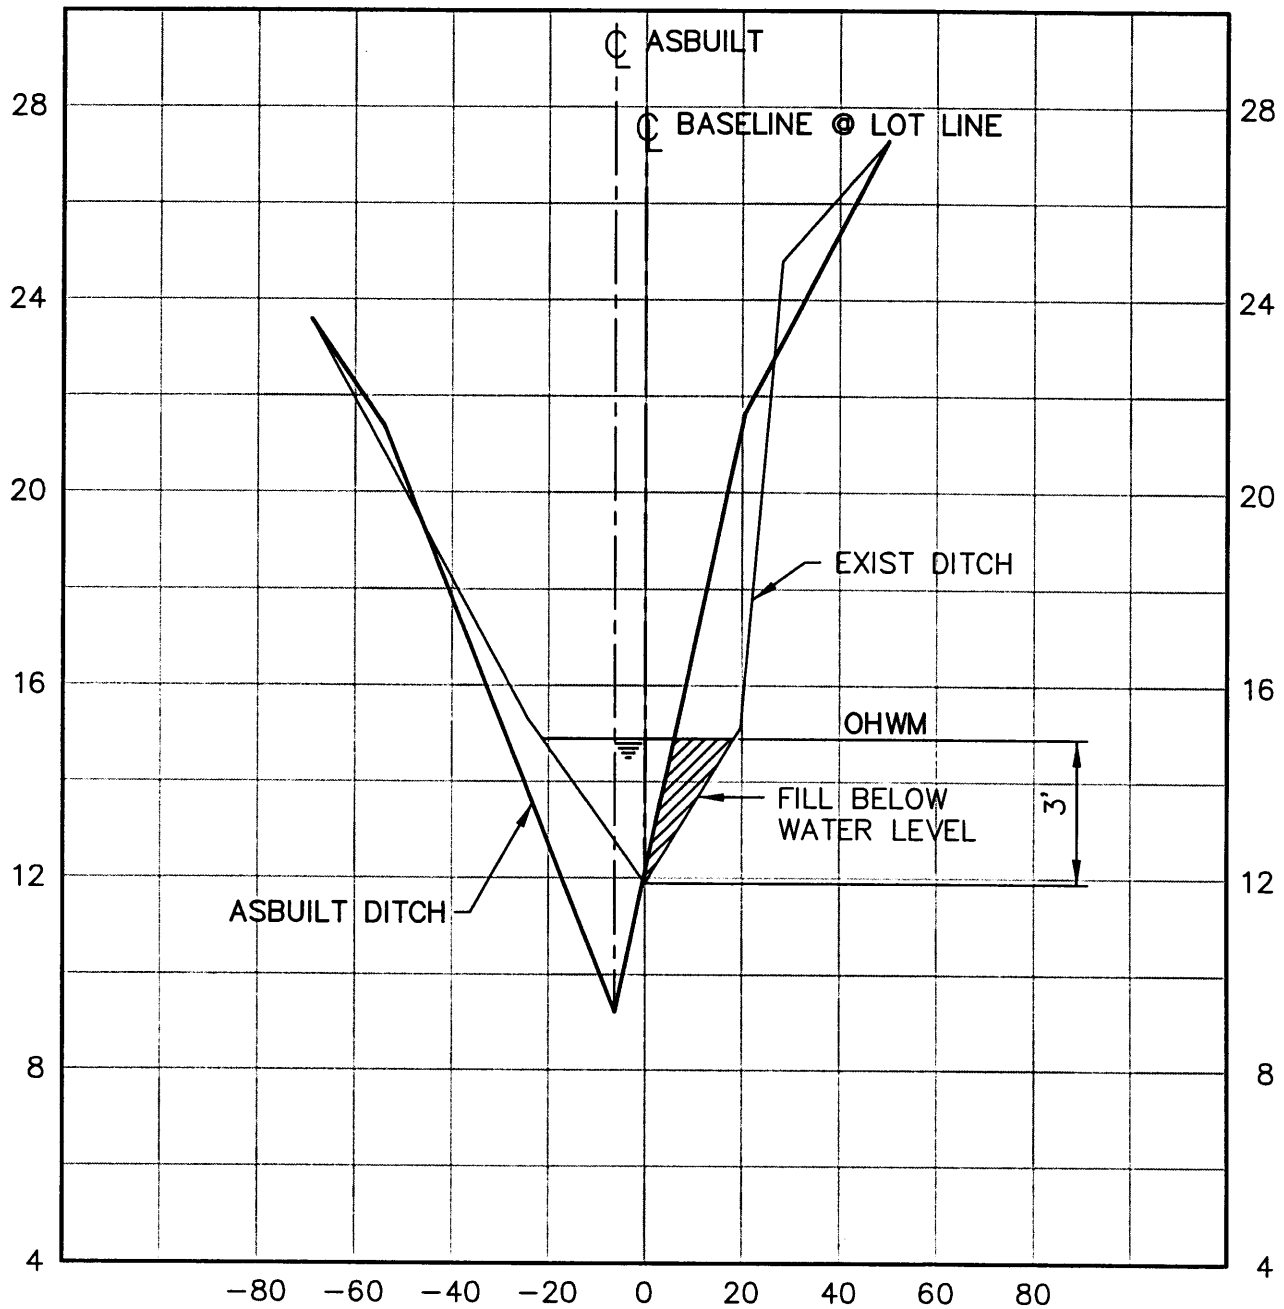
FIGURE 3

STA 15+00

COWARD CREEK BANK REPAIR
EXISTING CONDITIONS
CROSS-SECTION VIEW
GALVESTON COUNTY CONSOLIDATED
DRAINAGE DISTRICT

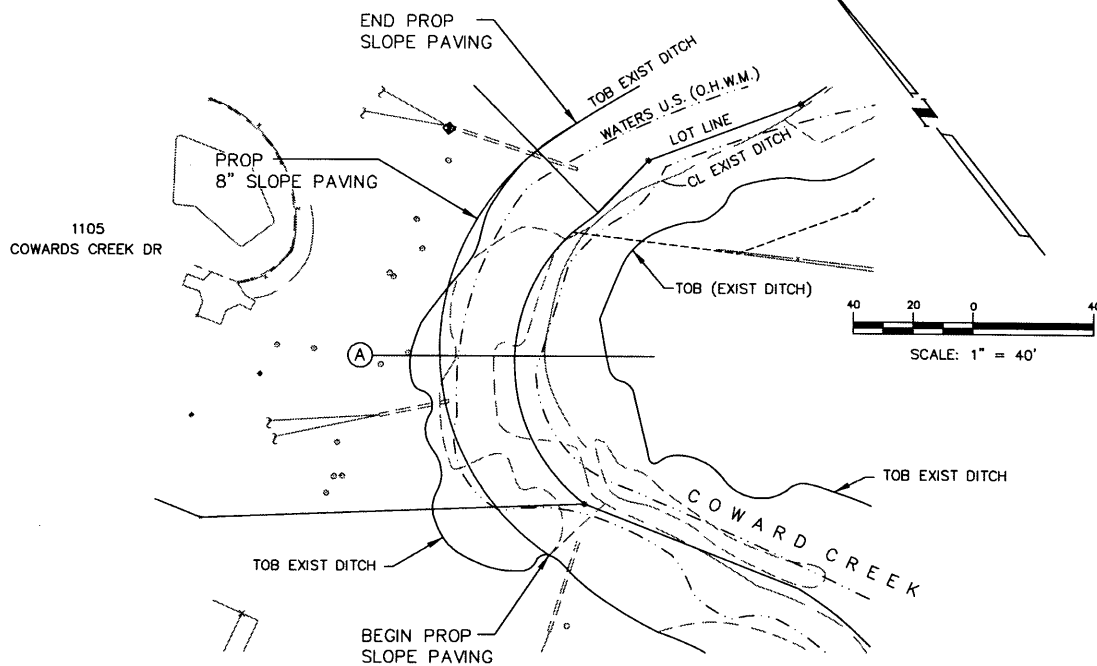
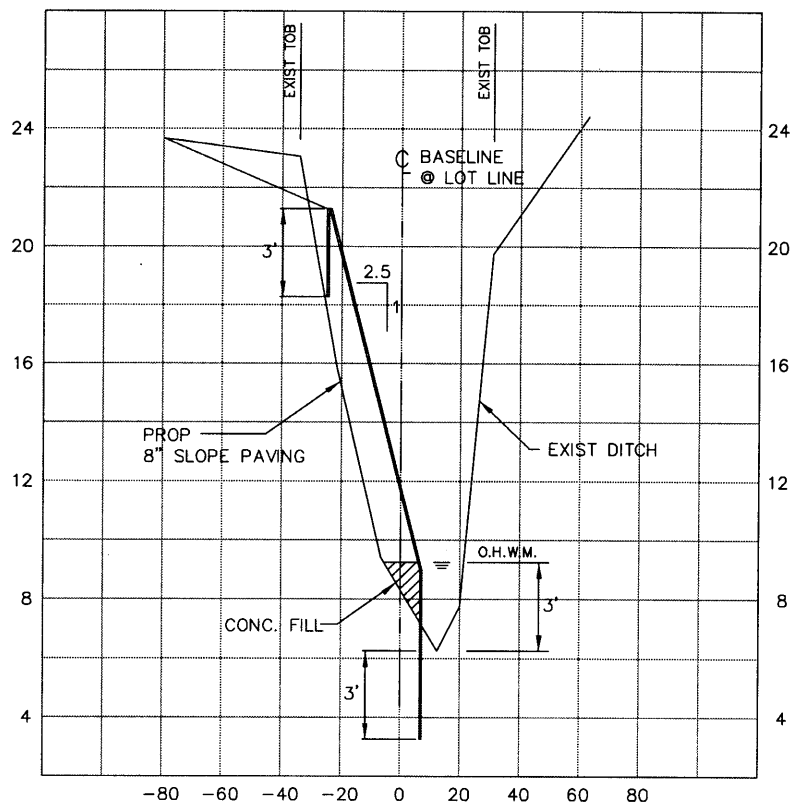
CROSS-SECTION 'A'
SCALE: H: 1"=40' V: 1"=4'

REVISED PLAN DRAWING
COWARD CREEK BANK REPAIR
USACE CASE # 1-4621

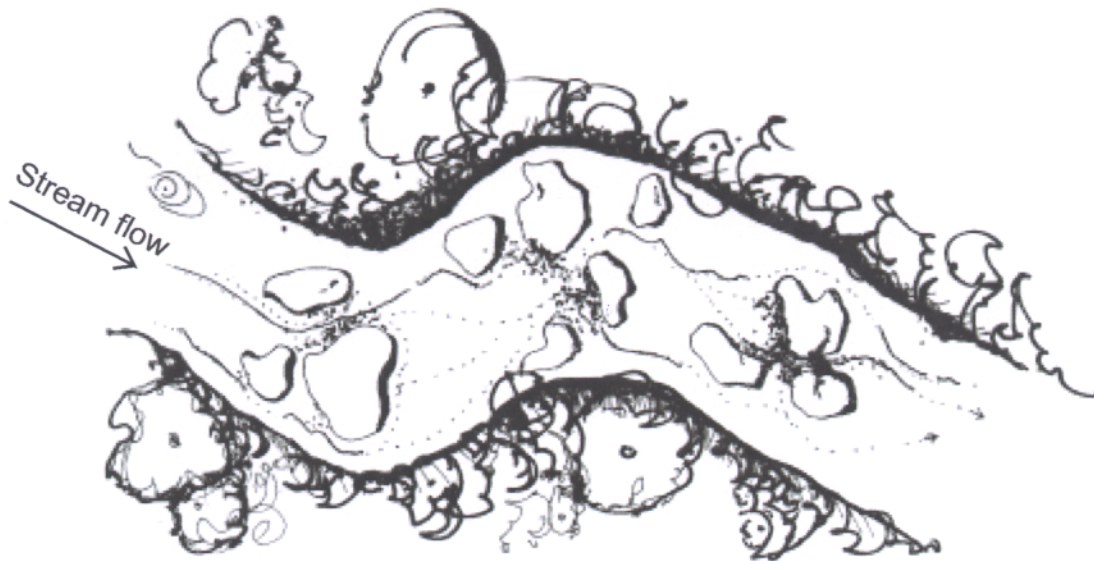
**Boulder Clusters
Plan View**

BOULDER CLUSTERS

Boulder clusters will be installed at three locations along the 1,500-foot segment that was impacted by unauthorized improvement activities. The proposed locations are depicted in Figure 1. The clusters will consist of irregularly shaped and angular boulders of approximately 3-foot diameter, and will be slightly embedded into the streambed to prevent movement downstream during high velocity conditions. Material removed in order to embed the boulders will be removed from the stream and disposed in an upland area. Incidental increases of turbidity occurring during installation will be of a minimal and temporary nature. Boulders will be placed in groups of three forming a triangular cluster, with spacing between boulders of approximately 6 inches to 1 foot. This configuration will provide in-stream cover and promote water oxygenation and scour pockets adjacent to the boulders when flow velocities exceed 2 cubic feet per second. A

The FISRWG suggests spacing clusters within the same stream segment approximately one-third of the stream width apart (2001). GCCDD will install two clusters per location and ensure that the spacing conforms to the FISRWG recommendations.
